MONUMENT RECORD

Corner ID: **CICr_E09-.5**

West-West 1/64 Corner

Sections 08 & 17- T07N-R01W, 2nd P.M.
Clear Creek Township, Monroe County, Indiana

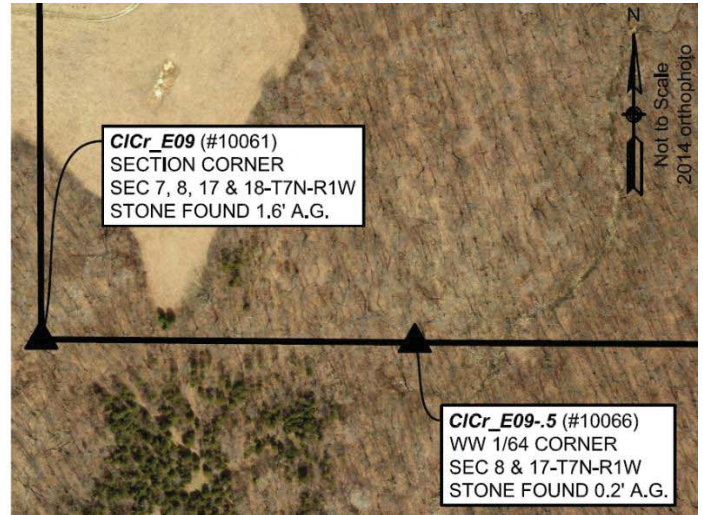
Photo Orientation & Description: CICr_E09-.5

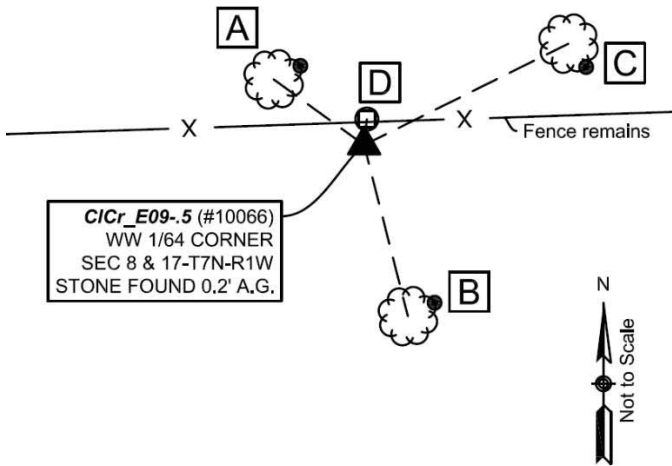
Photo Orientation & Description: Looking south at CICr_E09-.5
